## Monitoring of Substructure Building of Suramadu Bridge Causeway Segment on Surabaya Side Based on Corrosion Level

A. Setijorini<sup>1</sup>, A. Ratnaningsih<sup>2\*</sup>, Krisnamurti<sup>3</sup>

<sup>1,2\*,3</sup> Civil Engineering Department, University of Jember

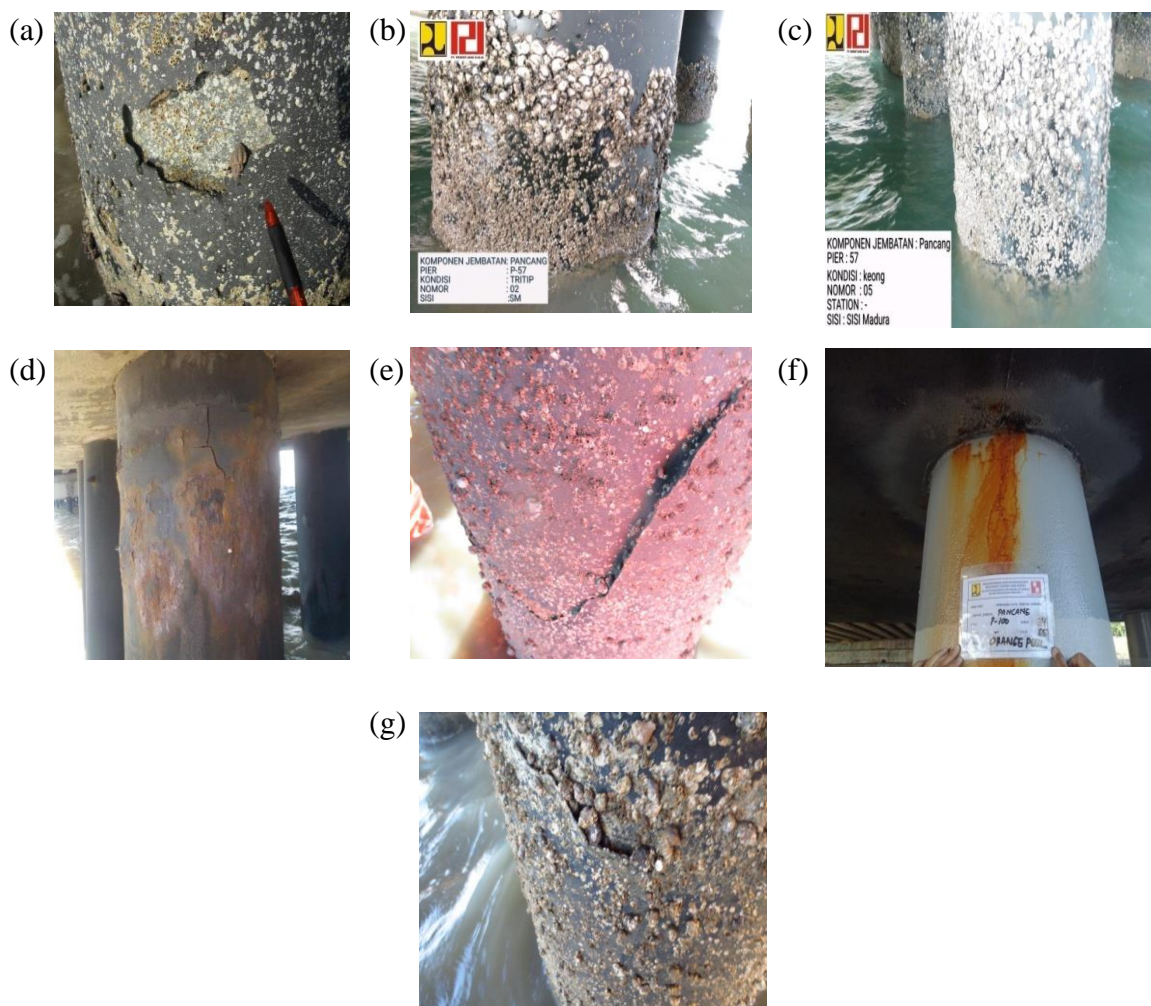
**Figure 4** (a) C-005 Metal Expose (b) C-008 Biofouling Tritip (c) C-009 Biofouling Keong (d) C-014 Blistering (e) C-016 Pin Holes (f) C-018 Orange Peel (g) C-020 Chalking Erosion

From **Figure 4(a)**, it can be seen that the damage to the piles with the type of damage to hollow iron and concrete is visible. The damage occurred to 488 piles. **Figure 4(b)** pile damage with the type of damage: many tritip organisms are attached to the pile. The damage occurred in 1580 piles. **Figure 4(c)** damage to the pile with the type of damage, there are many snails attached to the pile, the damage occurred on 234 piles. **Figure 4(d)** pile damage with

rust-type peeling/bubbling coating damage occurred on 150 piles. **Figure 4(e)** damage to piles with the type of damage to iron, torn piles the damage occurred to 72 piles. **Figure 4(f)** damage to piles with the type of damage to iron, corrosion, brownish-orange color, the damage occurred in 72 piles of 403 piles. **Figure 4(g)** damage to piles with the type of damage to the iron piles eroded due to tripping. The damage occurred to 24 piles. The above conditions mainly occur in the Splash Zone area (tidal area and areas affected by seawater splashes) at an elevation of -1.60 m to +1.90 m).

In general, the results of observations of the condition of the piles on the pile are filled with marine life in the tidal area, while for areas that have never been submerged in seawater, the condition is quite good. The splash zone is the area with the highest corrosion level, which occurs because the splash zone area is exposed to alternating currents between wet and dry continuously. In addition, the level of abrasion in this zone is quite high, so a strong protective layer is needed. The existence of damage to the protective layer (coating), both light and heavy, has not disrupted the integrity of the pile. However, the risk of increasing disturbance acceleration is expected to be very fast if corrective action is not taken. For the splash zone, disturbances of marine biota, namely tritip and snails, are identified. The activity of taking tritip by fishers with tools and boat collisions can damage the coating. From the inspection results on the components of the steel pile foundation, it can be categorized as a top priority recommendation to immediately get treatment because the damage is already at level-3 (bad condition) and level-4 (dangerous condition).

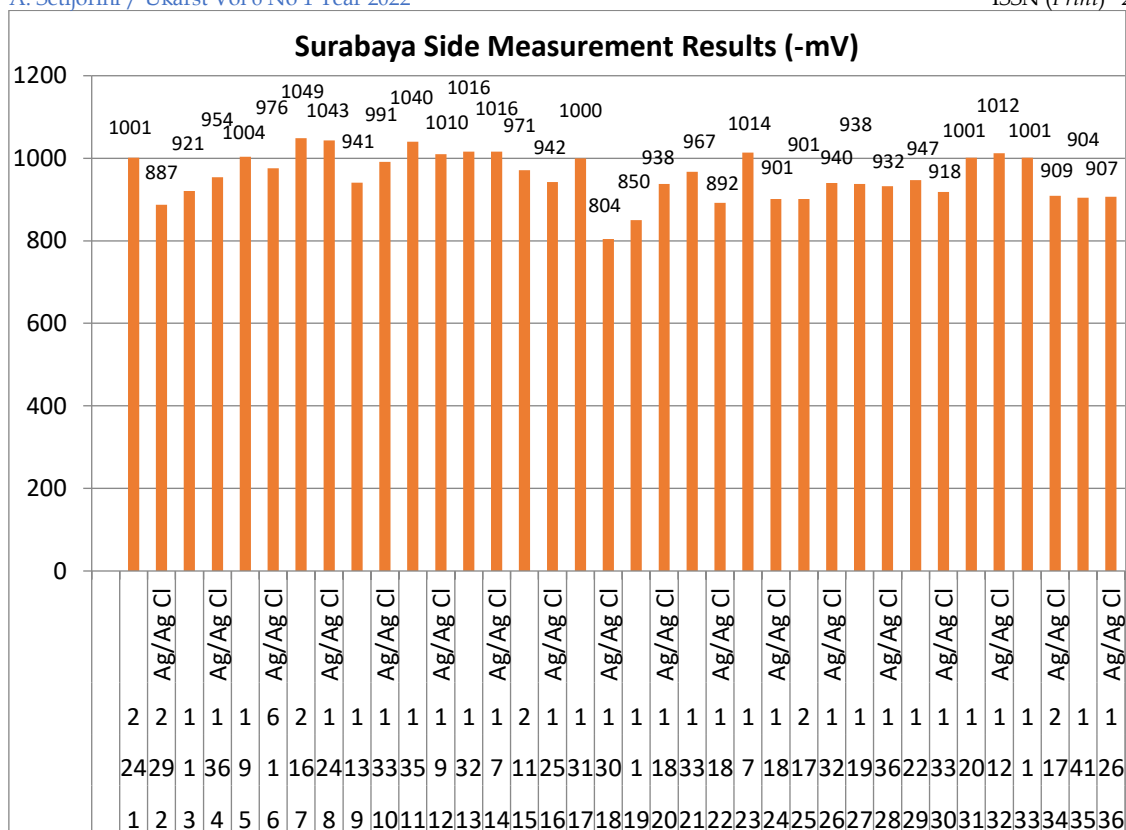
**Figure 5.** Bar chart of the potential measurement results for the Cathodic Protection Causeway area on the Surabaya side

Based on the graph of the measurement results in the Causeway area on the Surabaya side, there is 1 (one) pier that is on the threshold of protection, namely pier-18. Several other piers approaching the protection threshold value and need to be considered more intensively include pier-19, pier-22, pier-24, and pier-25. With details of P-18 all piles no.1 to no.36, P-19 piles no. 1, 2, 3, 9, 10, 11, 12, 14, 16, 17, 18, 19, 20, 21, 23, 33, P-22 pile no. 20, P-24 pile no. 18 and P.25 pile no.1. So for the Causeway on the Surabaya side, there is a replacement of 120 Kg Cathodic Protection (poles 600 mm) = 55 pcs.

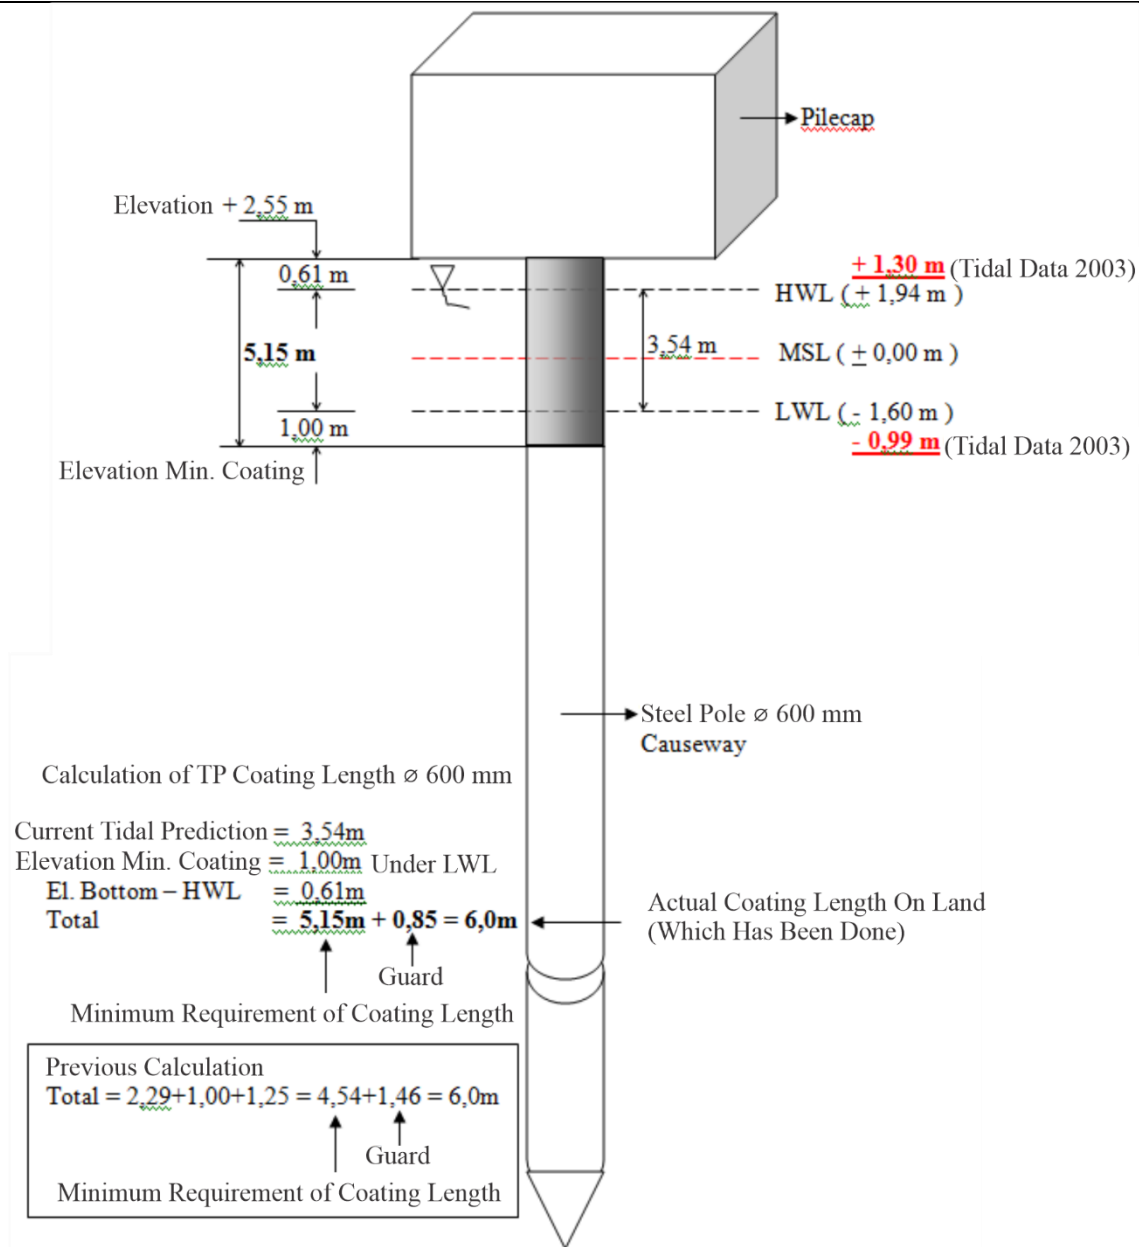
**Figure 6.** Details of the calculation of the need for coating on the pile

From the Figure above, the length of the steel pile coating with a thickness of 2000 microns is 6.0 meters long for the topmost connection (below the bottom pile cap) for the Causeway on the Surabaya side 600 mm (ABT-0 s/d P-36), for the Causeway side Madura 1000 mm (P-57 to P-68) and 600 mm (P-69 to ABT-102). To increase the coating thickness from 500 ~ 700 microns to 2000 microns, it is carried out at the stockyard on land before the steel piles are delivered to the piling location. For steel piles, the handling method is as follows:

- a. Under the Atmospheric Zone pile cap area with a length of 0.65 m from an elevation of +2.55 m to an elevation of +1.90 m, a 2000 micron thick glass flake coating is applied.

- b. Meanwhile, for the Splash Zone area, Jacketing HDPE (Sea Shield Series 200 DM) is carried out with a length of 3.50 m from an elevation of +1.90 m to an elevation of – 1.60 m,
- c. And for the Embedded Zone area, installation/replacement of the Sacrificial Anode is still carried out below the elevation – 1.60 m for 120 Kg (pole 600 mm) and 190 Kg (pole 1000 mm).
