Repair Performance Landslide and Slope Using Bore pile and Ground Anchor on Cipali Toll Road Km 103

A. Akhmudiyanto^{1*}, P. P. Rahardjo², R. Karlinasari³.

^{1*2,3} Civil Engineering Postgraduate Parahyangan University, Bandung.

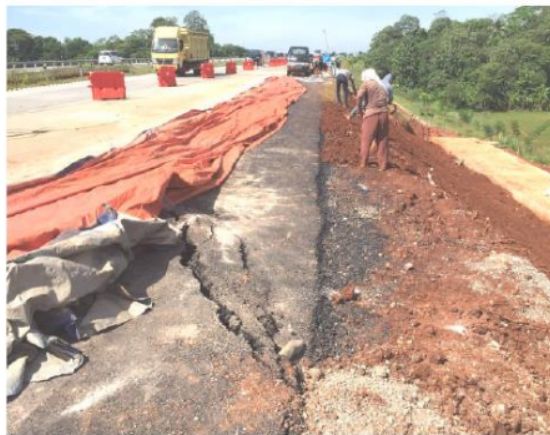
Figure 4. Crack Position

This soldier pile pole is tied using a capping beam. A few days after the soldier pile work was finished, cracks arose on the shoulder of the road as shown in Figure 3. This means there is movement on the shoulder of the road. This movement indicates that the pile is unable to withstand horizontal forces. So, it is necessary to make temporary strengthening. A sheet pile is installed temporarily on the shoulder of the road. The installation is intended to reduce the soil load behind the soldier pile.

From the above incident that the soldier using a diameter 50 stake is not able to withstand landslides. It is necessary to make a design that can withstand landslides. A stronger design using a bore pile with a diameter of 880 mm is installed in 2 rows, namely the shoulder of the road and the middle of the landslide area. The design plan is as shown in Figure 5.

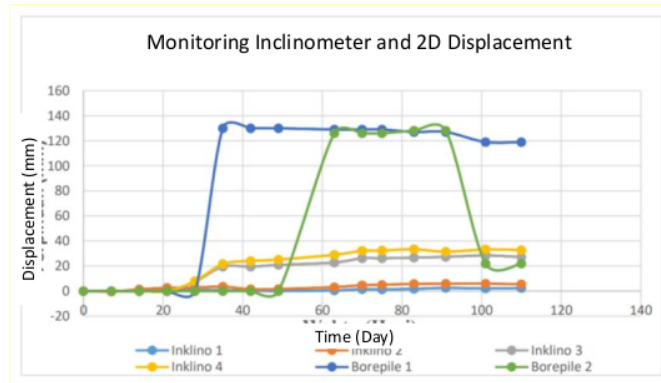
Figure 8. Monitoring Inclinator and 2D displacement

The next step is to compare the results of the analysis to the inclinometer measurements. Inclino meters for the landslide project on the Cipali 103 toll road were installed at 4 locations. The first and second on the phase 1 bore pile, namely inclino 1 and inclino 2, while the Inclino 3 and Inclino 4 are placed on the phase 2 bore pile. The locations of the inclinometer readings and Plaxis calculations are presented in the following figure:

From the image of the inclino, the actual field measurements on the BP1 bore pile (Borepile phase 1) have a maximum displacement of 5.41 mm. the results of calculations with Plaxis 8.6 on bore pile BP1 of a maximum of 130 mm, after being pulled with the ground anchor the displacement is 119 mm. This value is still more significant than the actual field on borepile1. In actual field measurements on bore pile 2 the results of the inclinometer displacement are 33.23 mm. From the results of calculations with Plaxis 8.6 the displacement value is 128 mm after the ground anchor is pulled, the displacement becomes 47.3 mm. the displacement value with this Plaxis calculation is still more significant than the actual measurement results in the field.
